TITLE XD10P Ground Fix		NUMBER TN-F441	REV C	PAGE 1 of 2
	DEPARTMENT Engineering	CREATED BY: K. Hultgren	EFFECTIVE DATE 4/05/06	APPROVED BY:

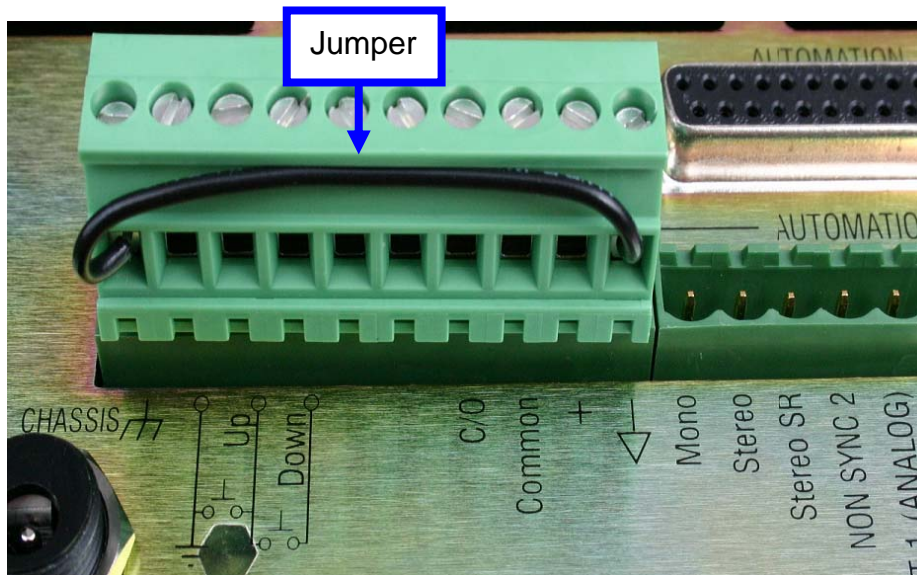
Figure 1

XD10P units produced until April 2006 have an open ground inside the unit. This open ground can produce noise in some installations. In most cases, simply adding a jumper between chassis ground and analog ground on a rear panel Phoenix connector will fix the problem. See Figure 1.

Units produced after April 2006 and after will have the grounds tied together inside the unit. Units produced before April 2006 that are having noise issues, will require a jumper added to the Phoenix connector, as shown below.

Some XD10P shipments in March – April 2006 will come with jumpers pre-installed on Phoenix connectors. Care should be taken when installing the Phoenix connectors to the back of the unit. Please make sure to put the Phoenix connector with the jumper on the left header. Putting the connector on the right header will lock the XD10P into the SR mode.

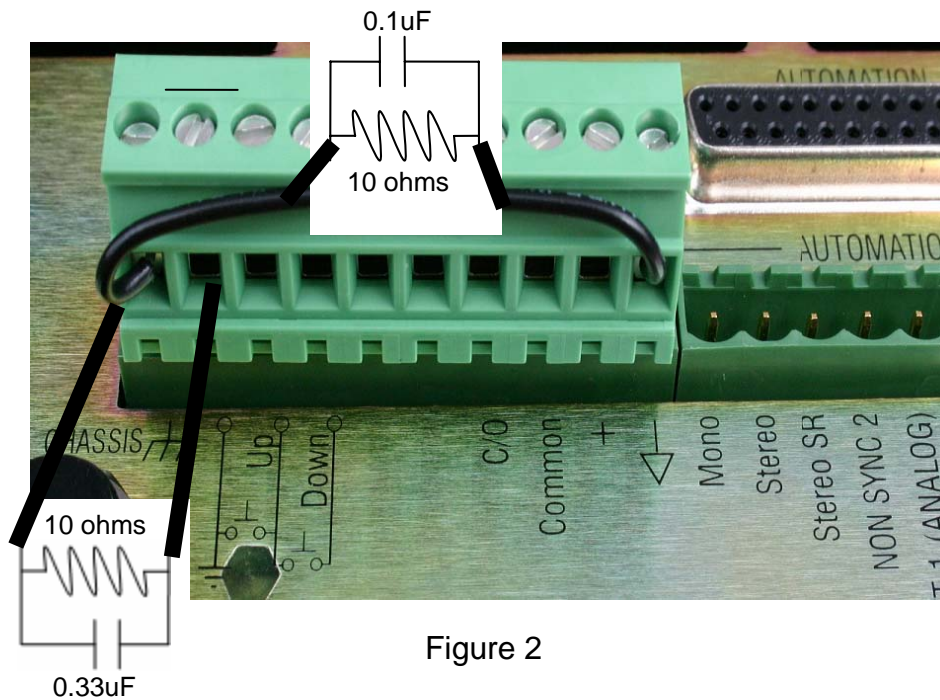
Figure 2

If the noise persists after adding the jumper between grounds, you must add two RC circuits between the grounds as shown in Figure 2.

- Add a 0.1uF capacitor in parallel with a 10 ohm ¼ watt resistor between chassis and digital grounds (adjacent to each other) on the Phoenix connector.
- Add a 0.33uF capacitor in parallel with a 10 ohm ¼ watt resistor between chassis and analog ground on the Phoenix connector.
