Barco service bulletin

Serial Number: 959
Date: 17/02/2011
Product: Lamp strike issues on DP2K-xxB series
Priority code*: C

1. LAMP STRIKE ISSUES ON DP2K-XXB SERIES

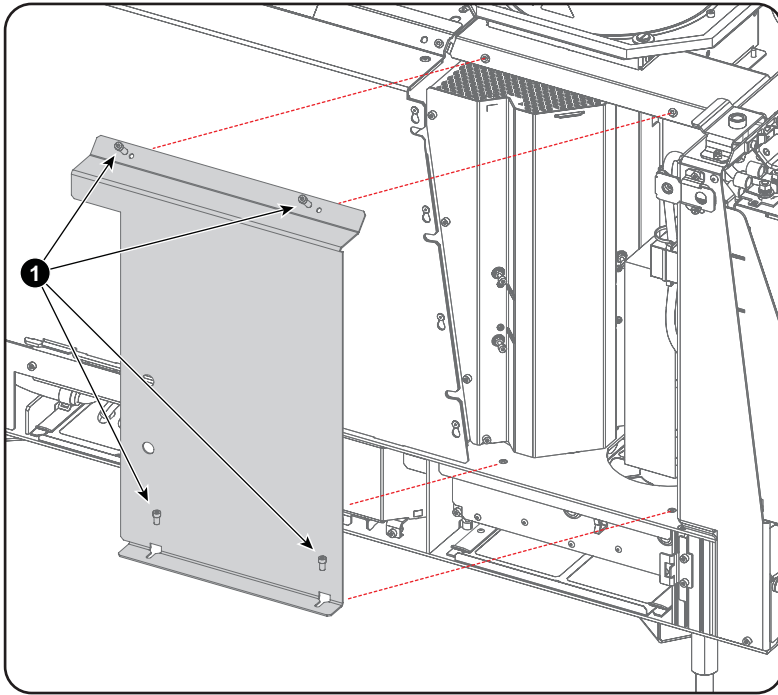
Image 2-4

The cover plate of the SPG inside the projector has an effect on the magnetic field created by the coil in the SPG (start puls generator). This causes a loss of energy that result in a lower ignition voltage.

By removing the inner cover plate you can increase the ignition voltage. This results directly in an easier lamp strike.

1. Remove the inner cover plate of the SPG/Cold Mirror compartment. Use a 3mm Allen wrench to release the four hexagon socket head cap screws (reference 1) as illustrated and take off the cover.
